HO-1086

8507 Guilford Road Private

# Maryland Historical Trust Maryland Inventory of Historic Properties Form

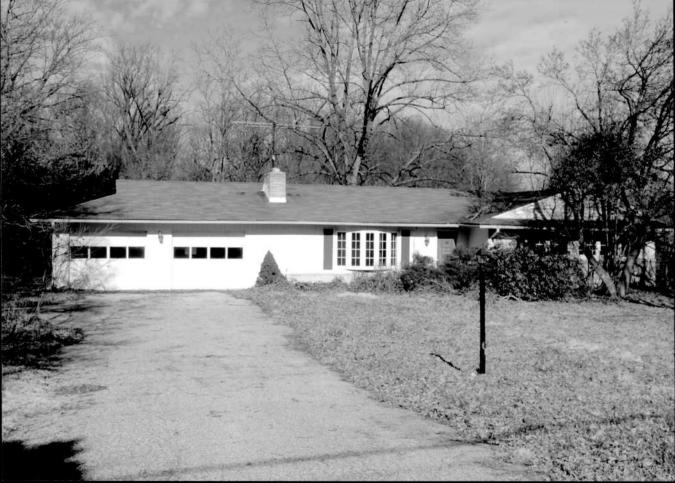
41111 40-1086 2507 Guilford Road Howard County, Maryland Ken Short 2012-02-27 MD SHPO South Elevation 1042

The south elevation is six bays, with roll-up garage doors in the two western bays, and they have four panels above four lights, with eight lights at the bottom. There is an interior ashlar stone chimney between these two bays and the two center bays, and it is south of the ridge. The west-center bay has a rounded bay window with five eight-light sash, and there is a low ashlar stone wall below it. The east-center bay has a door with two bolection-moulded panels. The eastern two bays each have paired six-over-six sash. There is a pent roof above these two bays, carried around from the east and west sides of the gable roof, with the gable end above this pent roof.

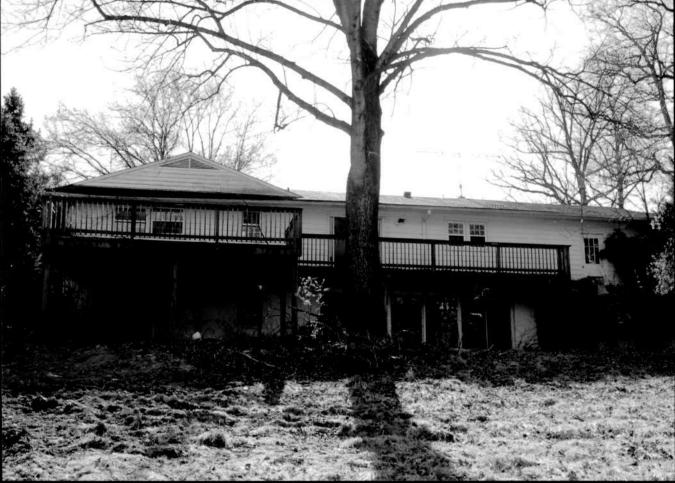
8507 Guilford Road Howard County, Maryland Ken Short 2012-02-27 MD SHPO Northelevation 20f2

The west elevation has no openings. The north elevation has two six-over-six sash in the eastern bays of the basement, three pairs of sliding glass doors in the center bays, and a brick retaining wall between the center and western bays, with the western bays below grade. The first story has a deck across the eastern and center bays. The eastern bay has paired six-over-six sash and the east-east-center bay has a single six-over-six sash. The east-center bay has a sliding glass door, the west-center bay has paired small six-over-six sash, and the western section has a single west bay with a door that has nine lights over a cross buck.
